**FIVE-YEAR REVIEW
FINAL REPORT**

**LEES LANE LANDFILL SITE
LOUISVILLE, JEFFERSON COUNTY, KENTUCKY**

June 1998

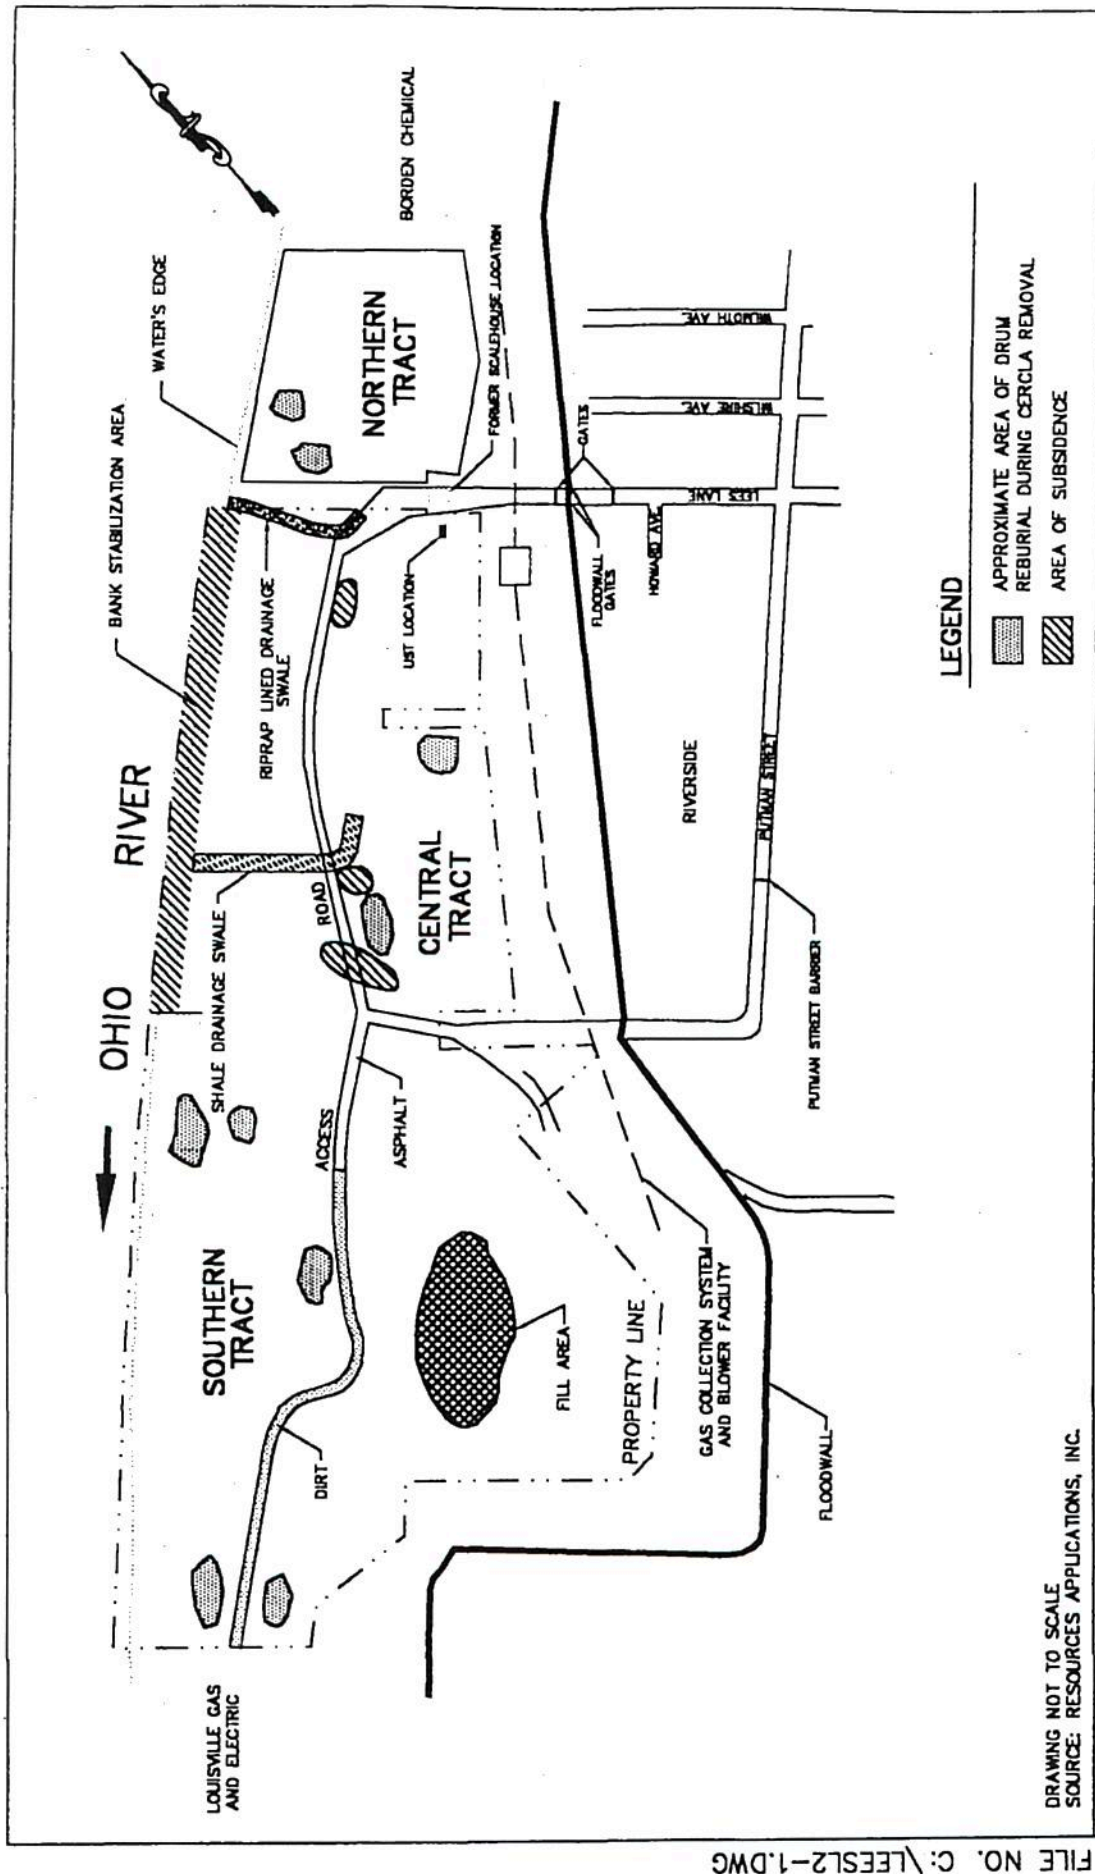
FEATURE MAP

A second barrier gate was present approximately 150 feet west of the first gate; however, the right hand side of the gate was missing and, therefore, the gate could no longer be locked. This gate is adjacent to the entrances to the track on the top of the floodwall.

Two other gates are present at the entrances to the floodwall. A southern gate consisting of two square panels was found to be in good condition but unlocked. A cable gate at the northern entrance to the floodwall was locked but was lying very close to the ground surface. Photographs 1 and 2 in Appendix D show these two gates.
